MODELLING OF ROCK SLOPE FAILURES DUE TO GEOLOGICAL DISCONTINUITIES TO MINIMIZE RISK FROM ROAD CUT FAILURES

RANJITH PREMASIRI

Department of Earth Resources Engineering, University of Moratuwa, Katubedda, Sri Lanka

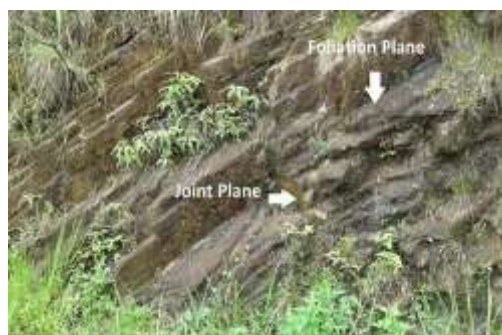
Fig. 1. An image showing rock outcrop with strongly developed major geological discontinuity planes such as foliation and joints planes. Location - road cut along Balangoda- Haputale road.

Most of the rock falls have taken place along geological discontinuities such as foliation planes and joint/fracture planes of rocks (Figure 1). Both road stretches studied indicate that the rock exposures on the road cut comprised high grade hard crystalline metamorphic rocks such as charnockite, charnockitic gneisses, garnet biotite gneisses, garnet granulite and quartzite. These rocks exhibit differently developed foliation and joint planes as major geological discontinuities. Fifteen locations of massive charnockite, 13 locations of Charnockitic gneiss, 5 locations of garnet biotite/or garnet granulitic gneiss and 11 locations of quartzite (Table 1) are observed at the 44 locations subjected to the study.

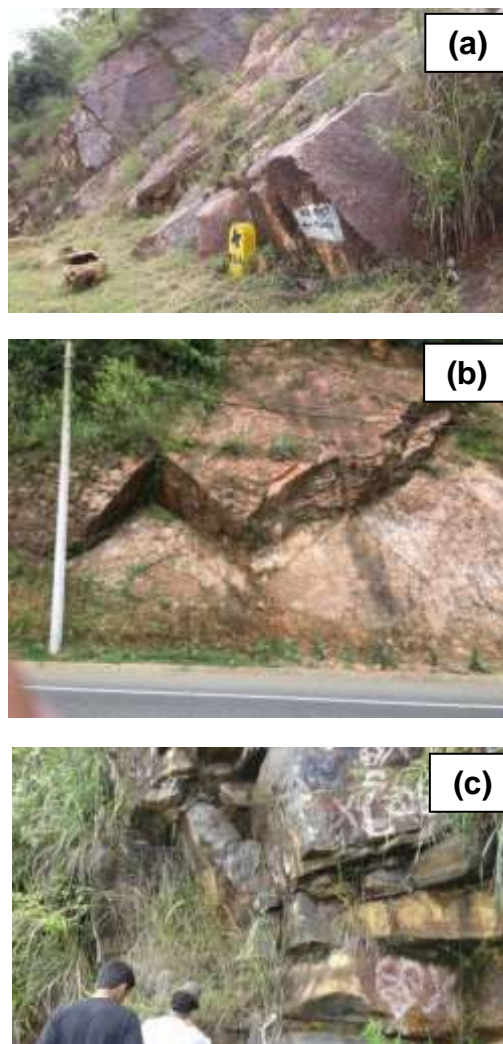
Failure index analysis of 44 locations showed that the most prominent failure was the wedge failure which observed at 20 locations out of 44 (Figure 3a). Toppling failures were observed at 6 locations (Figure 3b) while plane failures were observed at 9 locations (Figure 3c). When, the results of the numerical analysis are compared with ground observations, 64% of the results are compatible with the reality (Table 2).

Fig. 3. (a) Plan failure on a road cut along Balangoda- Haputale road. (b) Wedge failure on a road cut along Balangoda- Haputale road. (c) Toppling failure on a road cut along Balangoda- Haputale road.

Results derived from the model reveal that the slope should generally be modified from 7° to 38° angles from the existing slope angle to get optimum safety condition, whereas at some locations, road direction has to be

modified greatly up to 70° to get the required safety condition, which is not practicable. The field observations indicate that slope angle could be modified at many locations to minimise the risk of rock falls rather than modifying the road direction (Table 3).
